(1500) **ART-277**
1999-2006
SILVERADO/SIERRA
EXT./ REG CAB
REAR BUMP STOP
FRAME SECTION

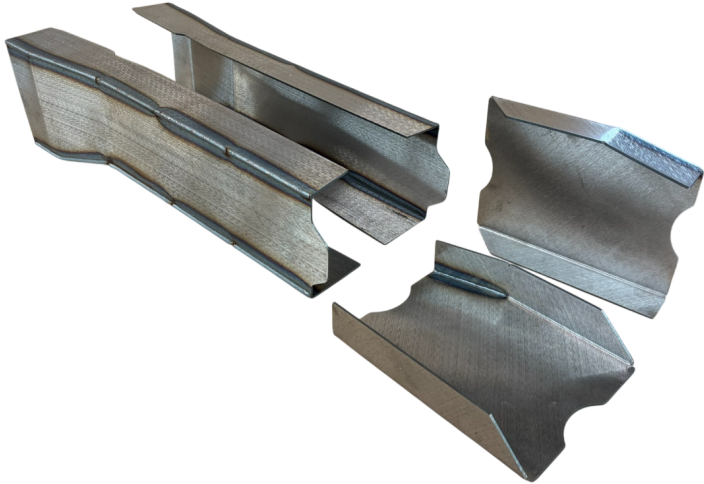
For Crew Cab models, a minor adjustment to the inside plate is required

- 1)** Raise the bed for access or detach it.
- 2)** Remove and cut away any rust or loose debris hanging.
- 3)** Remove bump stop (4wd model have a bracket)
- 4)** Test fit the outside kit first and inside kit will cap over from inside of frame. Mark the perimeter.
- 5)** Clean and sand down area where welds are needed.
- 6)** Slide outside kit on and tack weld. Weld section that inside cap will overlap
- 7)** Slide inside kit on and tack weld. When satisfied with placement weld perimeters 100%.
- 8)** Apply a rust-inhibiting primer, paint, or undercoating.
