ART-279
1999-2006
SILVERADO/SIERRA
(1500) ALL CAB STYLES
REAR BUMP STOP
REINFORCEMENT

IMPORTANT: Read and understand the General Instructions Before Installing SafeTCap® Frame Repair Kits

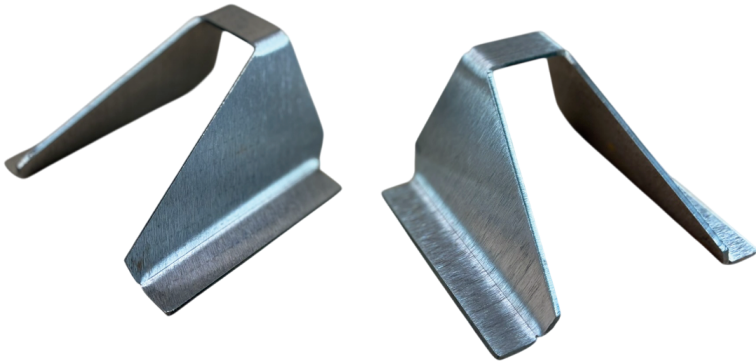
- 1) Raise the bed for access or detach it.
- 2) Get a few measurements vertically and horizontally.
- 3) Remove and cut away old bracket.
- 4) Clean and sand down area to bare metal.
- 5) Locate new bracket in position with measurements taken.
- 6) Tack weld bracket to the frame.
- 7) Double check if the bracket is in the correct location. When satisfied Weld all perimeters 100%.
- 8) Apply a rust-inhibiting primer, paint, or undercoating.
